**Flood Control Project Maintenance
Levee Inspections**

Fall 2016 Levee Maintenance Deficiency Summary Report

Sacramento Maintenance Yard Willow Slough Bypass

Unit Cover Sheet

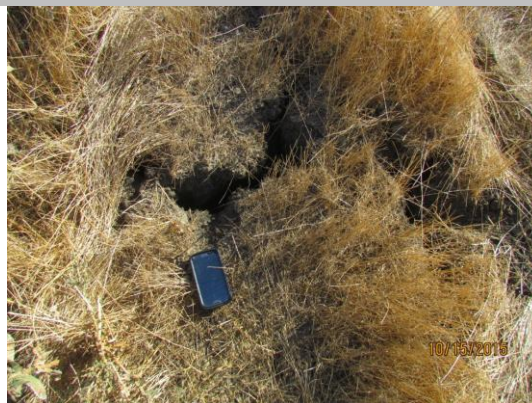
Photo 1 of 3 : FA_2016_ST0012_295_16_20160913_00010.jpg

LM Start	0.90	Rating **	M	Issue No.	16
LM End	0.90	Issue Type +	Ob	Location *	LS
Category	Earthen Levee			GPS Latitude/Longitude	
				Start	End
Item	Cracking			38.590456 °	38.590456 °
				-121.681952 °	-121.681952 °
DWR ID	DWR_ST0012_01_f_2015_16				
Comment Code					
CR1 : Monitor and have inspected by geotechnical engineer.					
Inspector Comment

View of the dessication cracking on the landward side of the levee. Fall 2015.

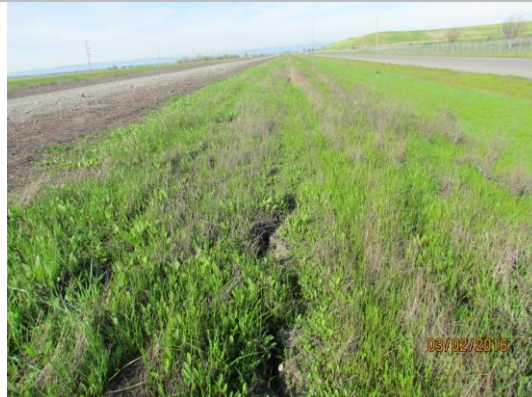
Photo 2 of 3 : FA_2016_ST0012_295_16_20160913_00011.jpg

View of the crack on the landward side of the levee looking upstream. Spring 2016.

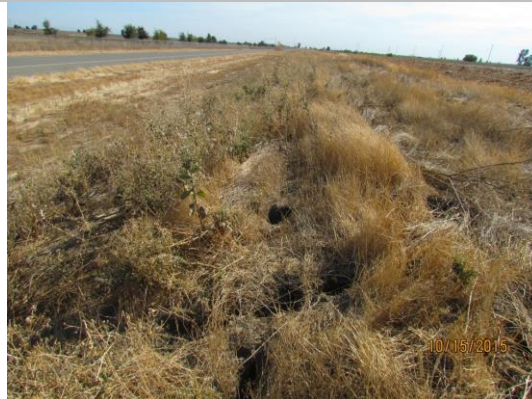
Photo 3 of 3 : FA_2016_ST0012_295_16_20160913_00012.jpg

Perspective view of the crack looking downstream. Fall 2015.

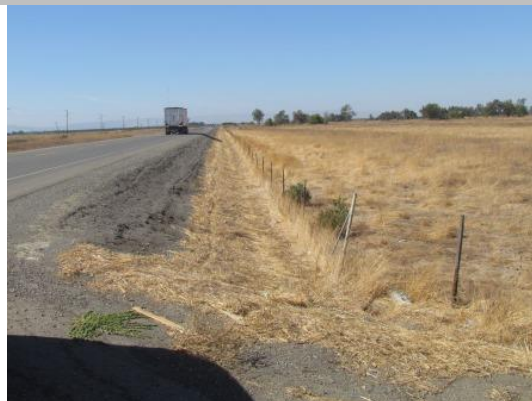
Photo 1 of 1 : FA_2016_ST0012_295_14_20161011_00018.jpg

LM Start	1.53	Rating **	M	Issue No.	14
LM End	2.20	Issue Type +	En	Location *	LS
Category	Earthen Levee			GPS Latitude/Longitude	
				Start	End
Item	Encroachments			38.590334 °	38.590466 °
				-121.693618 °	-121.705849 °
DWR ID	DWR_ST0012_01_f_2016_14				
Comment Code					
FE : Fence					
Inspector Comment					
No record of a permit related to this fence found in levee log.

View of fence encroaching 10-foot easement on landward side of the levee. Fall 2016.

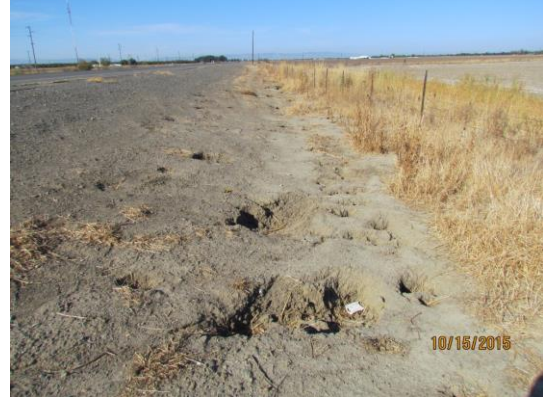
Photo 1 of 1 : FA_2016_ST0012_295_10_20160913_00002.jpg

LM Start	2.93	Rating **	M	Issue No.	10
LM End	3.00	Issue Type +	Ma	Location *	LS
Category	Earthen Levee			GPS Latitude/Longitude	
				Start	End
Item	Erosion / Bank Caving			38.590572 °	38.590653 °
				-121.719349 °	-121.720714 °
DWR ID	DWR_ST0012_01_s_2015_10				
Comment Code					
E2 : Schedule repair of erosion site prior to the next inspection.					
Inspector Comment					
Area is known to erode and may be because of the material of the levee.

View of the erosion on the landward side of the levee looking upstream.
Fall 2015.

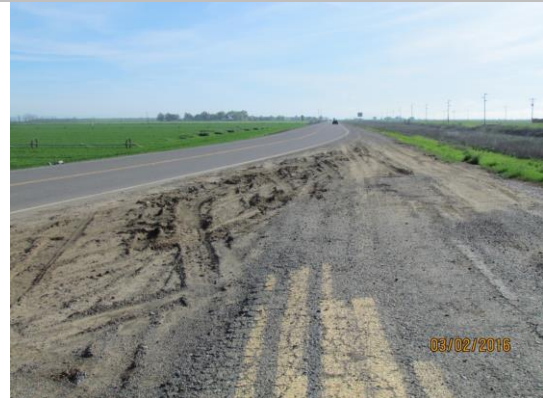
Photo 1 of 1 : FA_2016_ST0012_295_13_20160913_00006.jpg

LM Start	3.36	Rating **	M	Issue No.	13
LM End	3.36	Issue Type +	Ma	Location *	LS
Category	Earthen Levee			GPS Latitude/Longitude	
				Start	End
Item	Crown Surface / Depressions / Rutting			38.590620 °	38.590620 °
				-121.727385 °	-121.727385 °
DWR ID	DWR_ST0012_01_s_2016_13				
Comment Code					
C2 : Repair depressions or ruts in the crown or slope.					
Inspector Comment

View of the ruts created by vehicles on the crown of the levee looking downstream. Spring 2016.

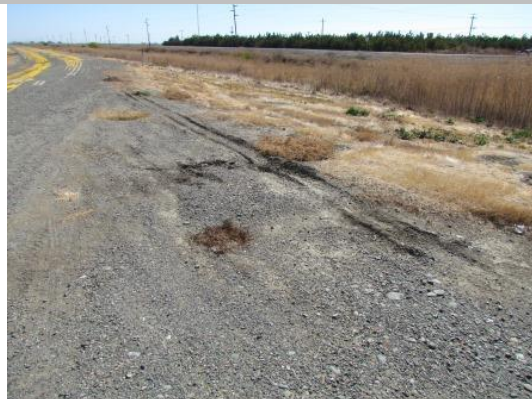
Photo 1 of 1 : FA_2016_ST0012_295_3_20161011_00015.jpg

LM Start	3.50	Rating **	M	Issue No.	3
LM End	3.50	Issue Type +	Ma	Location *	CR
Category	Earthen Levee			GPS Latitude/Longitude	
				Start	End
Item	Crown Surface / Depressions / Rutting			38.590731 °	38.590731 °
				-121.729906 °	-121.729906 °
DWR ID	DWR_ST0012_01_f_2016_3				
Comment Code					
C2 : Repair depressions or ruts in the crown or slope.					
Inspector Comment

Ruts on levee crown due to vehicular activity. Fall 2016.

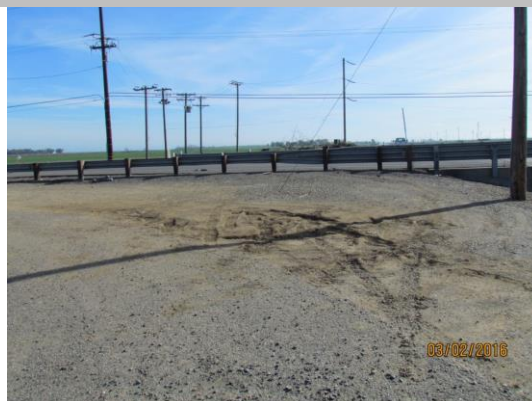
Photo 1 of 1 : FA_2016_ST0012_295_18_20160913_00014.jpg

LM Start	3.54	Rating **	M	Issue No.	18
LM End	3.54	Issue Type +	Ma	Location *	CR
Category	Earthen Levee			GPS Latitude/Longitude	
				Start	End
Item	Crown Surface / Depressions / Rutting			38.590685 °	38.590685 °
				-121.730657 °	-121.730657 °
DWR ID	DWR_ST0012_01_s_2016_18				
Comment Code					
C2 : Repair depressions or ruts in the crown or slope.					
Inspector Comment

View of the ruts caused by vehicles on the crown of the levee looking downstream. Spring 2016.

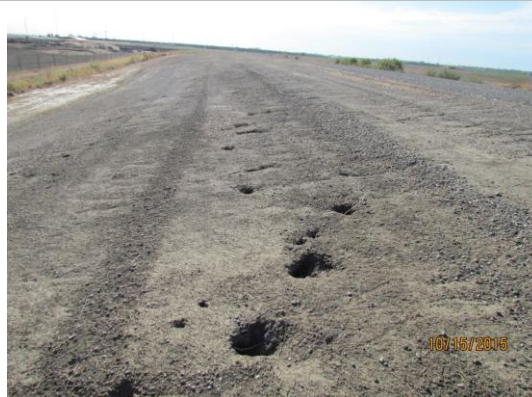
Photo 1 of 2 : FA_2016_ST0012_295_12_20160913_00004.jpg

LM Start	3.90	Rating **	M	Issue No.	12
LM End	3.90	Issue Type +	Ma	Location *	LS
Category	Earthen Levee			GPS Latitude/Longitude	
				Start	End
Item	Cracking			38.594149°	38.594149°
				-121.735254°	-121.735254°
DWR ID	DWR_ST0012_01_f_2015_12				
Comment Code					
CR1 : Monitor and have inspected by geotechnical engineer.					
Inspector Comment					
The sinkholes are caused by the material of the levee and runoffs. These are not rodent holes.

View of the sinkholes on the landward side of the levee looking downstream. Fall 2015.

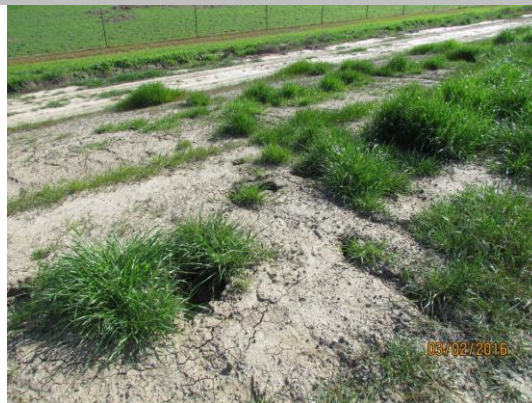
Photo 2 of 2 : FA_2016_ST0012_295_12_20160913_00005.jpg

View of the sinkholes on the landward side of the levee. Sinkholes are caused due to material of the levee and runoffs. Spring 2016.

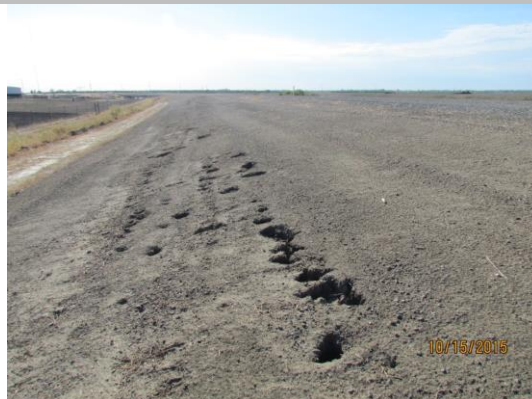
Photo 1 of 1 : FA_2016_ST0012_295_11_20160913_00003.jpg

LM Start	3.94	Rating **	M	Issue No.	11
LM End	3.94	Issue Type +	Ma	Location *	LS
Category	Earthen Levee			GPS Latitude/Longitude	
				Start	End
Item	Cracking			38.594645 °	38.594645 °
				-121.735712 °	-121.735712 °
DWR ID	DWR_ST0012_01_f_2015_11				
Comment Code					
CR1 : Monitor and have inspected by geotechnical engineer.					
Inspector Comment					
The sinkholes are caused by the material of the levee and runoffs. These are not rodent holes.

View of the sinkholes on the landward side of the levee looking downstream. Fall 2015.

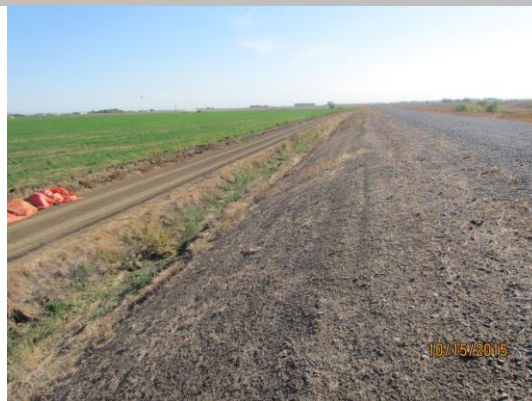
Photo 1 of 1 : FA_2016_ST0012_295_4_20160913_00001.jpg

LM Start	4.12	Rating **	M	Issue No.	4
LM End	4.60	Issue Type +	En	Location *	LS
Category	Earthen Levee			GPS Latitude/Longitude	
				Start	End
Item	Encroachments			38.596784 °	38.599845 °
				-121.737662 °	-121.744830 °
DWR ID	DWR_ST0012_01_s_2012_4				
Comment Code					
DT : Ditch					
Inspector Comment					
Ditch is at the levee toe.

View of the ditch on the landward side of the levee looking downstream. Fall 2015.

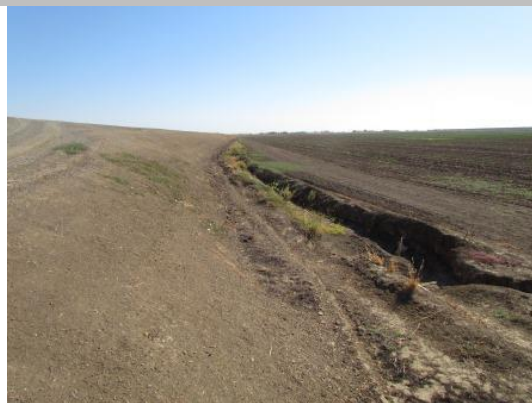
Photo 1 of 2 : FA_2016_ST0012_296_7_20161011_00029.jpg

An updated view of the ditch near LM 0.29. Fall 2016.

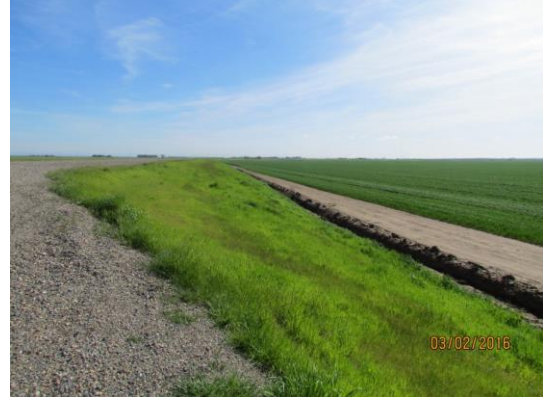
Photo 2 of 2 : FA_2016_ST0012_296_7_20160913_00004.jpg

View of the ditch on the landward side of the levee looking downstream. Spring 2016.

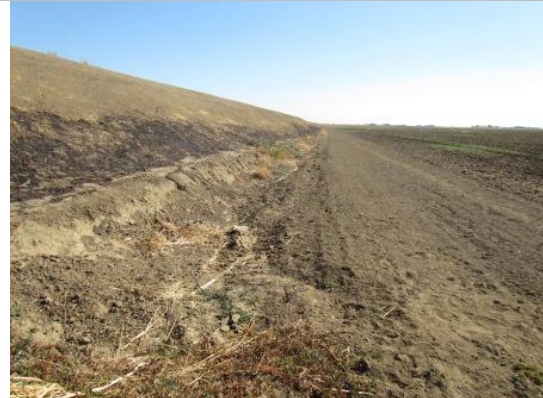
Photo 1 of 1 : FA_2016_ST0012_296_26_20161011_00030.jpg

LM Start	0.40	Rating **	M	Issue No.	26
LM End	0.56	Issue Type +	En	Location *	LS
Category	Earthen Levee			GPS Latitude/Longitude	
				Start	End
Item	Encroachments			38.599045 °	38.599033 °
				-121.747108 °	-121.744180 °
DWR ID	DWR_ST0012_02_f_2016_26				
Comment Code					
AT : Agricultural tilling					
Inspector Comment

View of a tilling issue at LS levee toe near LM 0.40 where ditch ends. Fall 2016.

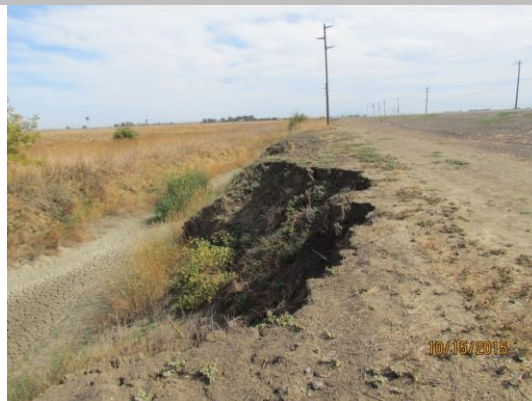
Photo 1 of 1 : FA_2016_ST0012_296_8_20160913_00005.jpg

LM Start	1.77	Rating **	M	Issue No.	8
LM End	1.77	Issue Type +	Ma	Location *	WS
Category	Earthen Levee			GPS Latitude/Longitude	
				Start	End
Item	Erosion / Bank Caving			38.589966 °	38.589966 °
				-121.727072 °	-121.727072 °
DWR ID	DWR_ST0012_02_s_2012_8				
Comment Code					
E2 : Schedule repair of erosion site prior to the next inspection.					
Inspector Comment

View of the erosion on the edge of the channel looking downstream. Fall 2015.

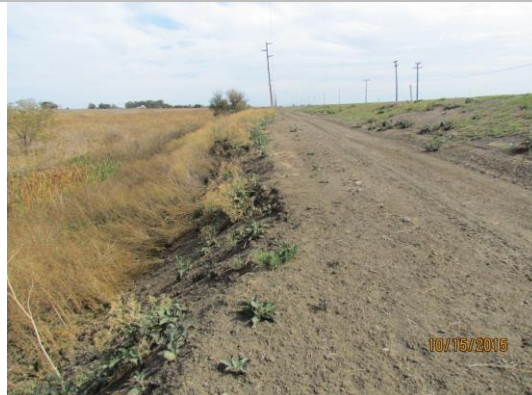
Photo 1 of 2 : FA_2016_ST0012_296_5_20160913_00001.jpg

View of the erosion on the edge of the channel on the waterward side of the levee looking downstream. Fall 2015.

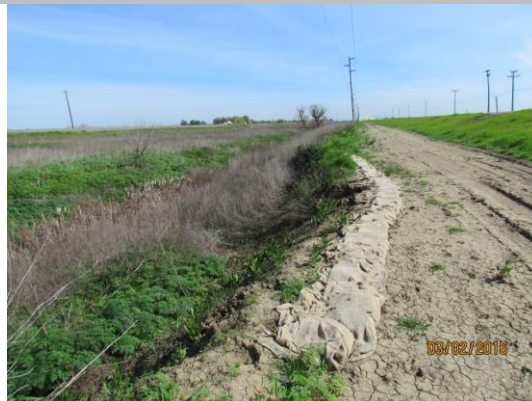
Photo 2 of 2 : FA_2016_ST0012_296_5_20160913_00002.jpg

View of the erosion on the edge of the channel on the waterward side of the levee looking downstream. Spring 2016.

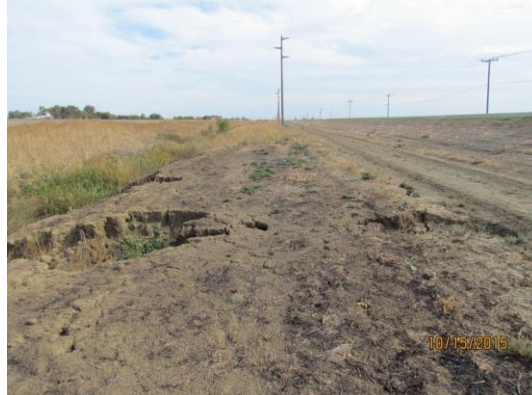
Photo 1 of 2 : FA_2016_ST0012_296_19_20160913_00018.jpg

View of the erosion at the edge of the channel on the waterward side of the levee looking downstream. Fall 2015.

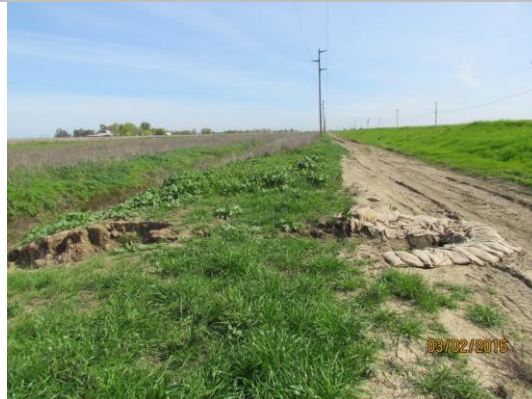
Photo 2 of 2 : FA_2016_ST0012_296_19_20160913_00019.jpg

View of the erosion at the edge of the channel on the waterward side of the levee looking downstream. Spring 2016.

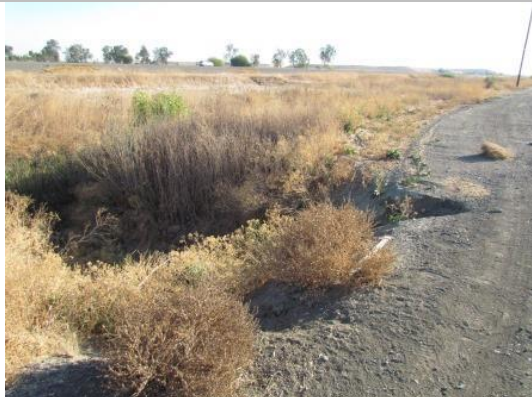
Photo 1 of 3 : FA_2016_ST0012_296_9_20161011_00041.jpg

LM Start	2.97	Rating **	M	Issue No.	9
LM End	2.97	Issue Type +	Ma	Location *	WS
Category	Earthen Levee			GPS Latitude/Longitude	
				Start	End
Item	Erosion / Bank Caving			38.589686 °	38.589686 °
				-121.705041 °	-121.705041 °
DWR ID	DWR_ST0012_02_f_2014_9				
Comment Code					
E2 : Schedule repair of erosion site prior to the next inspection.					
Inspector Comment

An updated view of erosion site on waterward side of the levee that keeps on growing. Fall 2016.

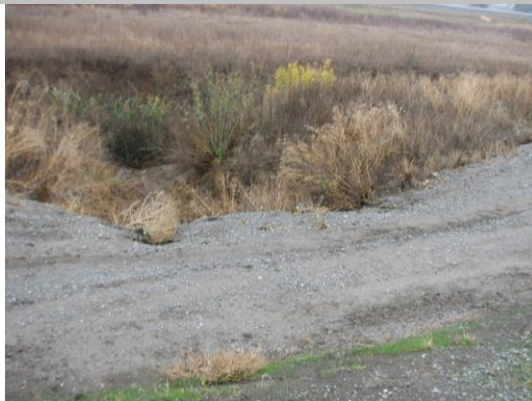
Photo 2 of 3 : FA_2016_ST0012_296_9_20160913_00006.jpg

Erosion on toe road. Fall 2014.

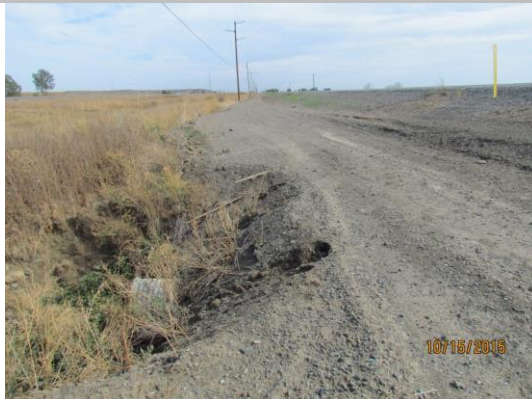
Photo 3 of 3 : FA_2016_ST0012_296_9_20160913_00007.jpg

View of the erosion on the waterward side of the levee looking downstream. Fall 2015.

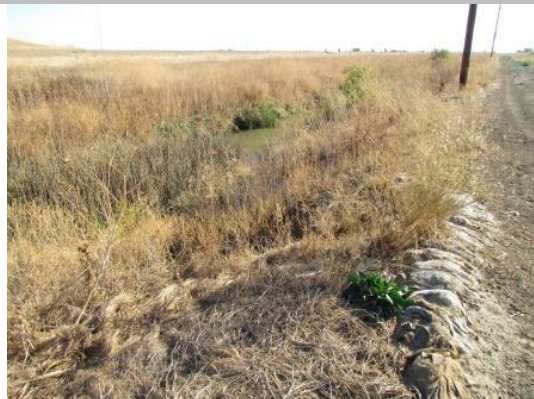
Photo 1 of 1 : FA_2016_ST0012_296_4_20161011_00039.jpg

View of erosion site on waterward side of the levee. Fall 2016.

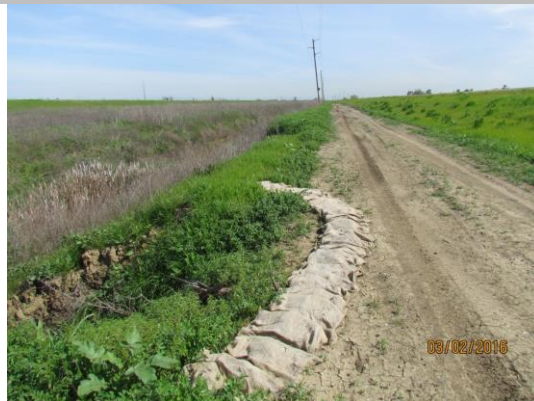
Photo 1 of 1 : FA_2016_ST0012_296_18_20160913_00017.jpg

LM Start	3.95	Rating **	M	Issue No.	18
LM End	3.95	Issue Type +	Ma	Location *	WS
Category	Earthen Levee			GPS Latitude/Longitude	
				Start	End
Item	Erosion / Bank Caving			38.589508 °	38.589508 °
				-121.686850 °	-121.686850 °
DWR ID	DWR_ST0012_02_s_2016_18				
Comment Code					
E1 : Note and monitor erosion site.					
Inspector Comment

View of the erosion on the waterward side looking downstream. Spring 2016.

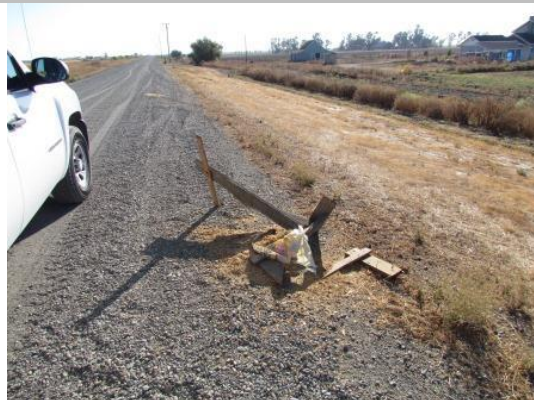
Photo 1 of 1 : FA_2016_ST0012_296_14_20161011_00038.jpg

LM Start	4.18	Rating **	M	Issue No.	14
LM End	4.18	Issue Type +	Ma	Location *	LS
Category	Earthen Levee			GPS Latitude/Longitude	
				Start	End
Item	Encroachments			38.589516 °	38.589516 °
				-121.682585 °	-121.682585 °
DWR ID	DWR_ST0012_02_f_2016_14				
Comment Code					
GA : Garbage					
Inspector Comment

Garbage on landside slope. Fall 2016.

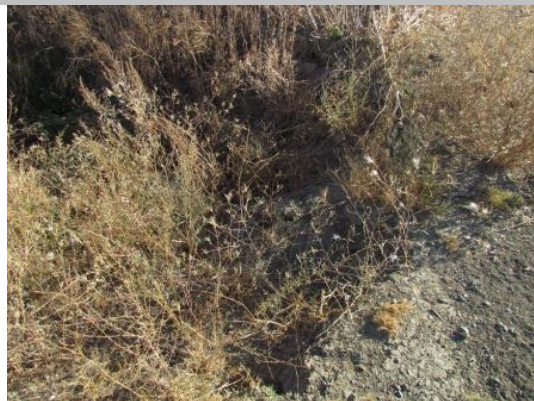
Photo 1 of 3 : FA_2016_ST0012_296_11_20161011_00037.jpg

LM Start	4.29	Rating **	M	Issue No.	11
LM End	4.29	Issue Type +	Ma	Location *	WS
Category	Earthen Levee			GPS Latitude/Longitude	
				Start	End
Item	Erosion / Bank Caving			38.589550 °	38.589550 °
				-121.680632 °	-121.680632 °
DWR ID	DWR_ST0012_02_f_2014_11				
Comment Code					
E2 : Schedule repair of erosion site prior to the next inspection.					
Inspector Comment

An updated view of the erosion site that keeps on growing toward WS levee slope. Fall 2016.

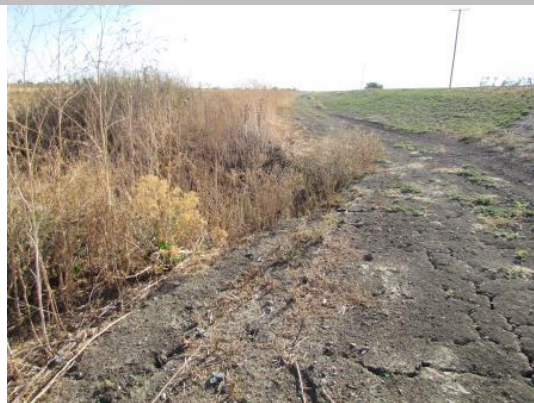
Photo 2 of 3 : FA_2016_ST0012_296_11_20161011_00035.jpg

Perspective view of the site. Fall 2016.

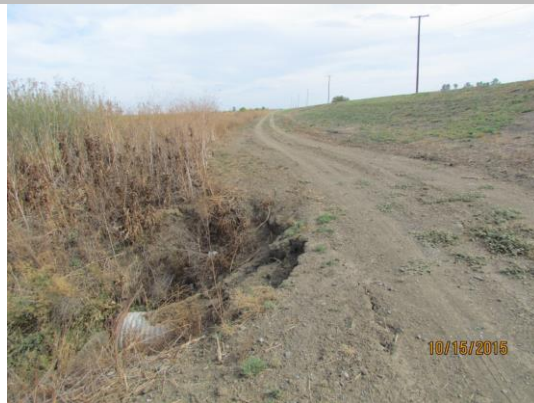
Photo 3 of 3 : FA_2016_ST0012_296_11_20160913_00010.jpg

View of the erosion at the edge of the channel on the waterward side of the levee looking downstream. Fall 2015.

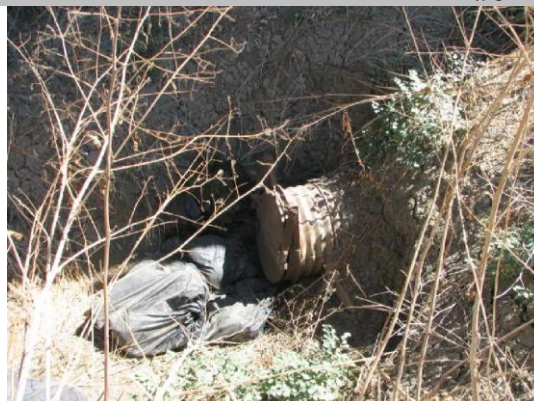
Photo 1 of 2 : UCIP_FA_2016_45285_22809.jpg

LM Start	4.59	Rating **	M	Issue No.	28
LM End	4.59	Issue Type +	En	Location *	WS
Category	Supplemental			GPS Latitude/Longitude	
				Start	End
Item	DWR UCIP Field Study			38.589575 °	38.589575 °
				-121.674950 °	-121.674950 °
DWR ID					
Comment Code					
Inspector Comment					
FS_ID:45285 DS_ID:546 EP_NO: 10319 Repair Type: Non-Urgent Crossing Status: Found UCIP Comments: Material removed from inlet last fall. Outlet cleared FIELD_STRUCT_DESC: 24-inch CM drainpipe through the levee, 15.0 feet below the crown. Flap gate on the waterward end. (A.B.O. No. 10319 - Bell). O&M manual 120, revision Dec 2010. FS Date: 5/14/2015 1:36:11 PM

Waterside view- pipe and flap gate.

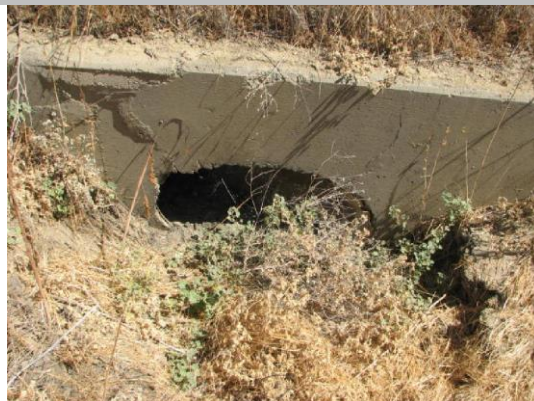
Photo 2 of 2 : UCIP_FA_2016_45285_22811.jpg

Landside view- pipe and headwall.

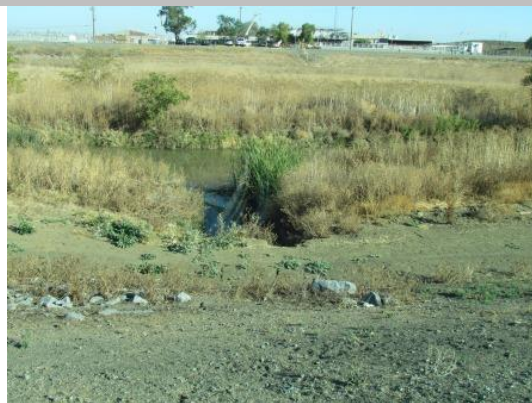
Photo 1 of 3 : FA_2016_ST0012_296_15_20161011_00034.jpg

LM Start	5.05	Rating **	M	Issue No.	15
LM End	5.05	Issue Type +	Ma	Location *	WS
Category	Earthen Levee			GPS Latitude/Longitude	
				Start	End
Item	Erosion / Bank Caving			38.589570 °	38.589570 °
				-121.666588 °	-121.666588 °
DWR ID	DWR_ST0012_02_s _ 2015_15				
Comment Code					
E2 : Schedule repair of erosion site prior to the next inspection.					
Inspector Comment

An updated view of the erosion site that keeps on growing toward WS levee slope. Fall 2016.

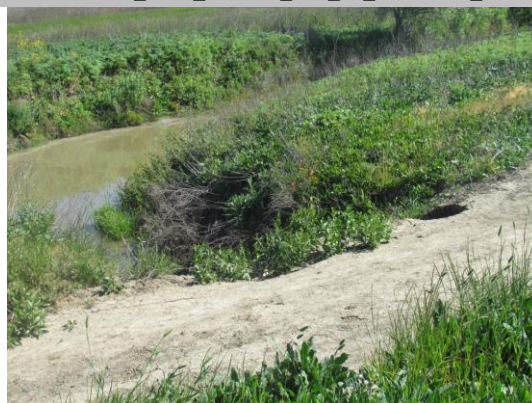
Photo 2 of 3 : FA_2016_ST0012_296_15_20160913_00014.jpg

View of the erosion on the edge of the channel on the waterward side of the levee. Spring 2015.

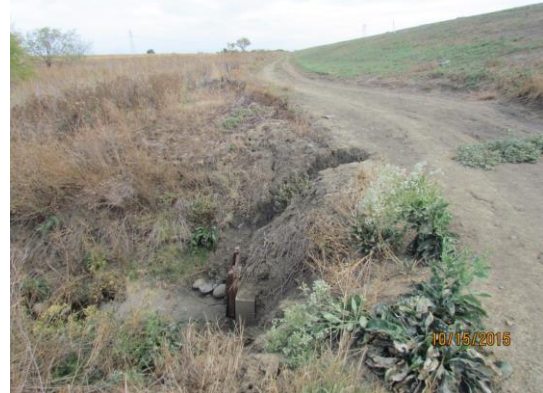
Photo 3 of 3 : FA_2016_ST0012_296_15_20160913_00015.jpg

LM Start	5.05	Rating **	M	Issue No.	15 (cont)	
LM End	5.05	Issue Type +	Ma	Location *	WS	
Category	Earthen Levee			GPS Latitude/Longitude		
				Start		End
Item	Erosion / Bank Caving			38.589570 °		38.589570 °
				-121.666588 °		-121.666588 °
DWR ID	DWR_ST0012_02_s_2015_15					
Comment Code						
E2 : Schedule repair of erosion site prior to the next inspection.						
Inspector Comment

View of the erosion at the edge of the channel on the waterward side of the levee looking downstream. Fall 2015.

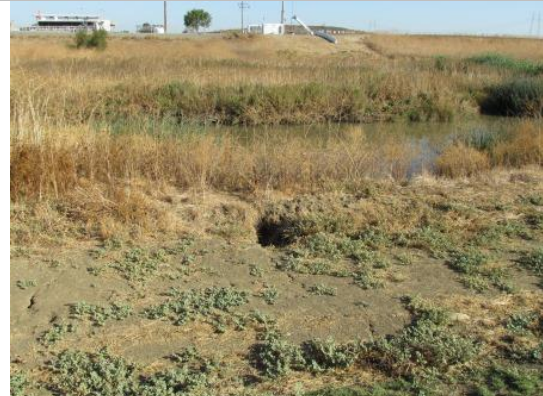
Photo 1 of 1 : FA_2016_ST0012_296_17_20161011_00033.jpg

View of a site that may become a larger erosion site in the future. Waterward side of the levee looking downstream. Fall 2016.

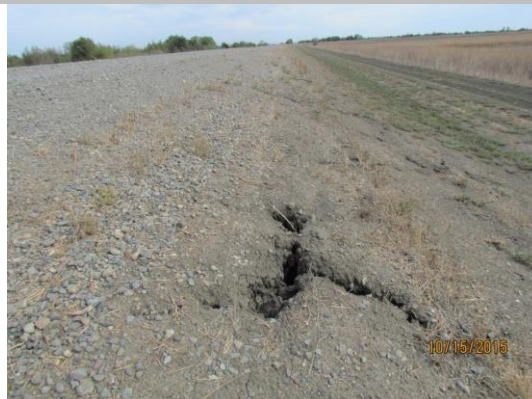
Photo 1 of 2 : FA_2016_ST0012_296_22_20160913_00021.jpg

LM Start	5.72	Rating **	M	Issue No.	22
LM End	5.72	Issue Type +	Ob	Location *	LS
Category	Earthen Levee			GPS Latitude/Longitude	
				Start	End
Item	Cracking			38.589499 °	38.589499 °
				-121.654098 °	-121.654098 °
DWR ID	DWR_ST0012_02_f_2015_22				
Comment Code					
CR1 : Monitor and have inspected by geotechnical engineer.					
Inspector Comment

View of the dessication cracking on the landward side of the levee looking downstream. Fall 2015.

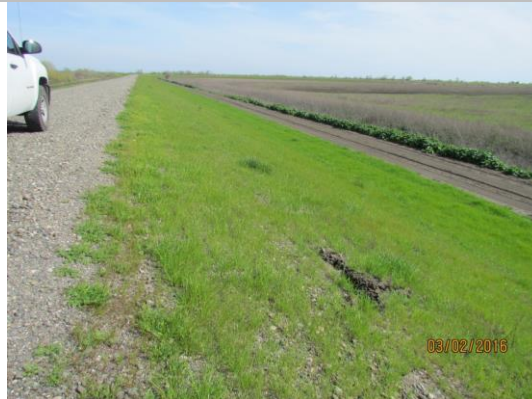
Photo 2 of 2 : FA_2016_ST0012_296_22_20160913_00022.jpg

View of the dessication crack on the landward side of the levee looking downstream. Spring 2016.

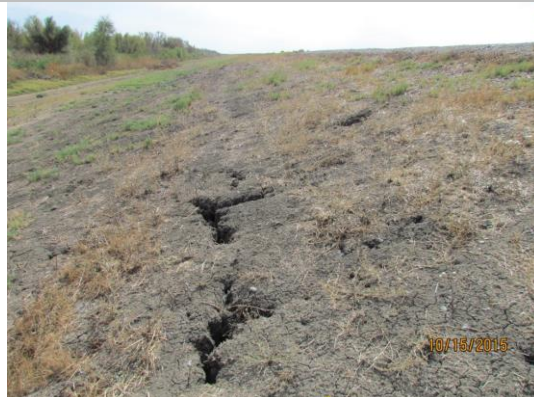
Photo 1 of 2 : FA_2016_ST0012_296_24_20160913_00023.jpg

LM Start	6.16	Rating **	M	Issue No.	24
LM End	6.16	Issue Type +	Ob	Location *	WS
Category	Earthen Levee			GPS Latitude/Longitude	
				Start	End
Item	Cracking			38.587826 °	38.587826 °
				-121.647364 °	-121.647364 °
DWR ID	DWR_ST0012_02_f_2015_24				
Comment Code					
CR1 : Monitor and have inspected by geotechnical engineer.					
Inspector Comment

View of the dessication cracking on the waterward side of the levee looking downstream. Fall 2015.

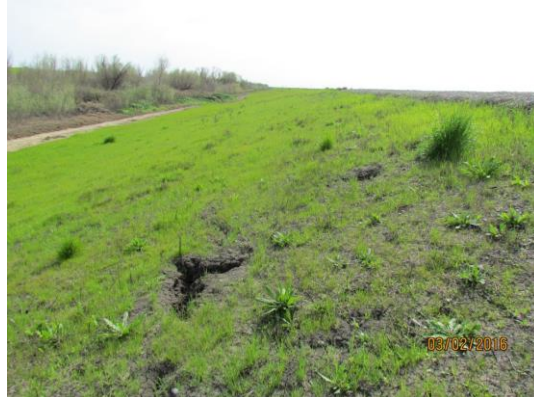
Photo 2 of 2 : FA_2016_ST0012_296_24_20160913_00024.jpg

View of the dessication cracks on the waterward side of the levee looking downstream. Spring 2016.

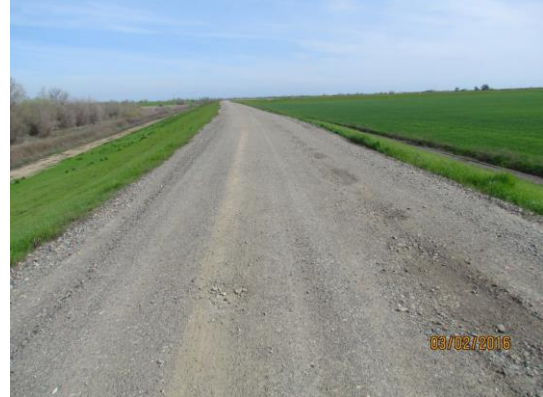
Photo 1 of 1 : FA_2016_ST0012_296_25_20160913_00025.jpg

View of the crown of the levee looking downstream. Road needs to be regraded. Spring 2016.
